Wheelock Tract Solar Project Conservation Commission Site Visit Report Addendum 8/25/21

Wheelock Tract Solar Project Site Visit

August 25, 2021

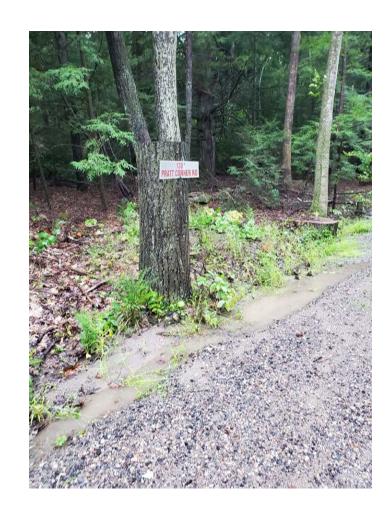
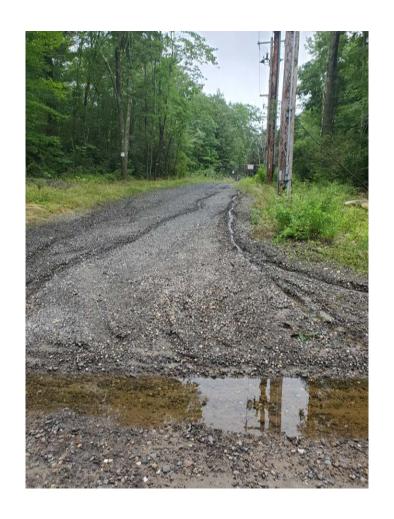
- Driveway is severely eroded along length of driveway and at intersection with Pratt Corner Road.
- In addition to necessary repairs, consider adding larger culvert under driveway, additional drainage swales, and stormwater containment/roadside swale at intersection with Pratt Corner Road.

Chronic erosion and sediment discharge onto Pratt Corner Road

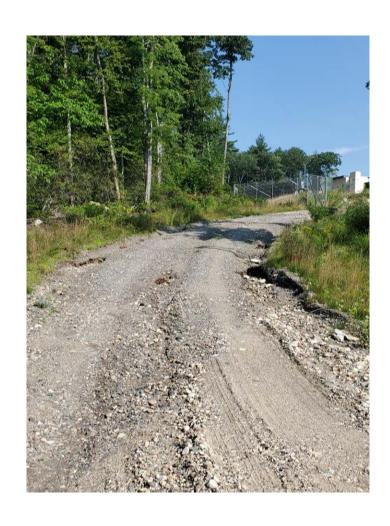
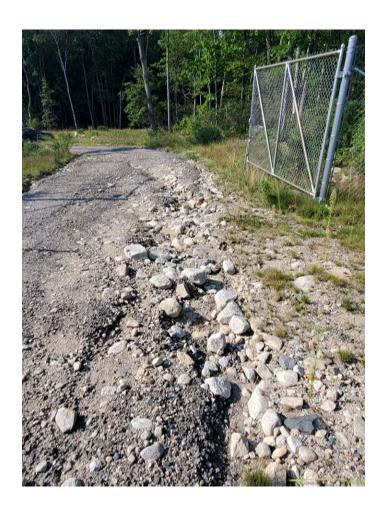
Access Road: evidence of significant erosion

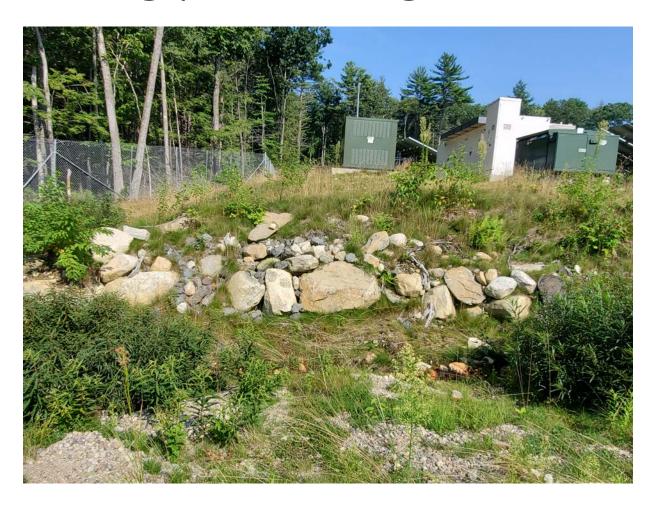
Retaining wall between driveway and battery pad, showing partial vegetation on slope

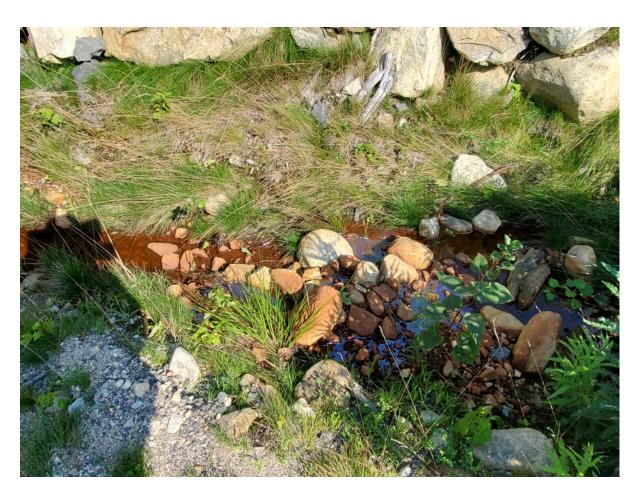
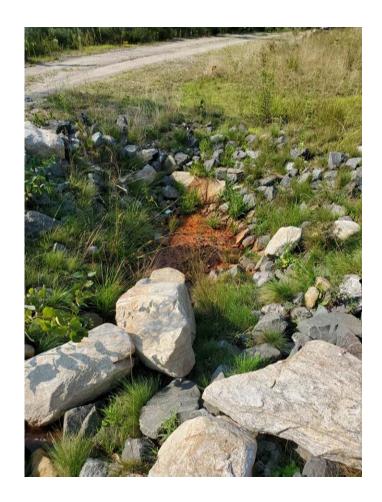
- Quantity of ferrous water is unusual for natural sources in this area. Iron-stained water is draining into a large detention basin that is functioning as a year-round wetland now.
- Source of discharge is unclear and merits investigation.
- Consider tracing staining to source and do a test boring or small pit to determine source.
- Determine whether remediation is necessary based upon investigation.

Drainage swale along driveway with running water and evidence of unusually high iron content (source of iron unknown)

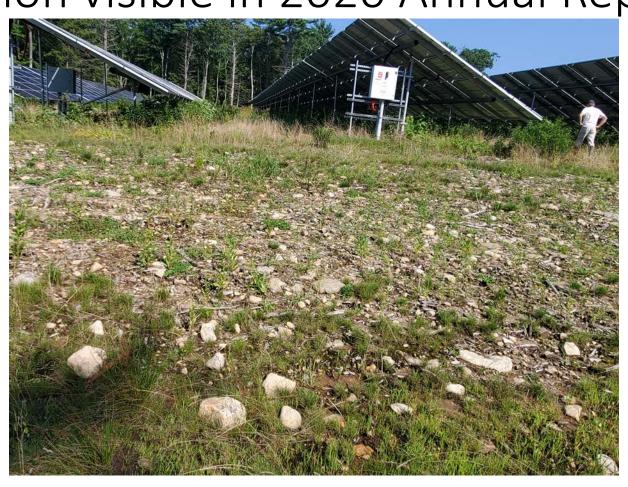
- Slope is insufficiently vegetated and shows signs of erosion. Runoff from slope may be contributing to excess water on the access road.
- Consider reseeding and adding other erosion controls.

Slope abutting driveway with insufficient vegetation and evidence of chronic erosion. Erosion visible in 2020 Annual Report.

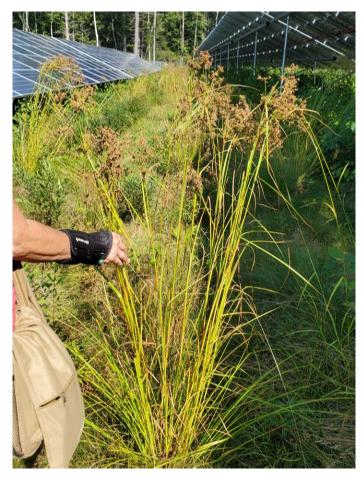
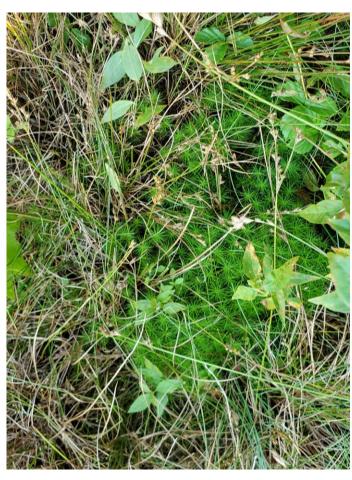
Wetlands plants established between arrays, indicating long-term presence of water

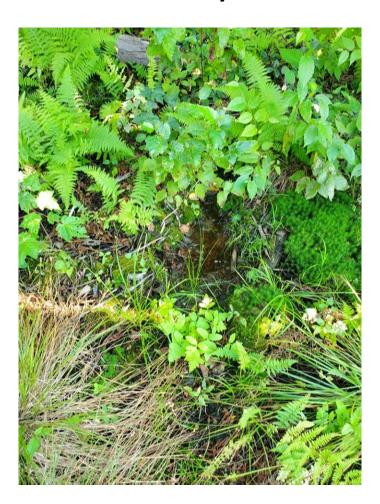
Standing water in equipment ruts between arrays

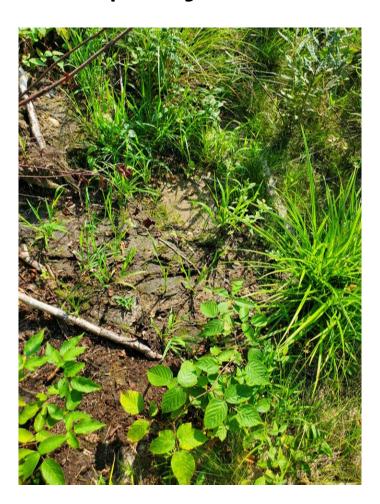
Erosion sediments along eastern side of project

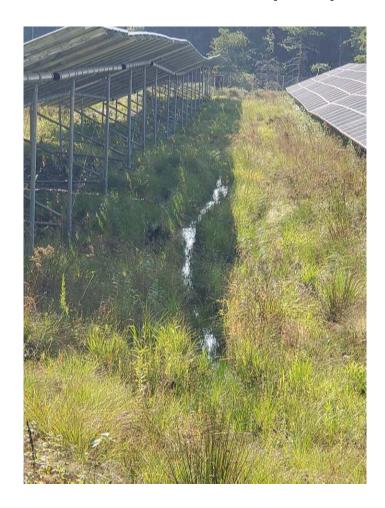
Western view between arrays showing standing water in equipment ruts

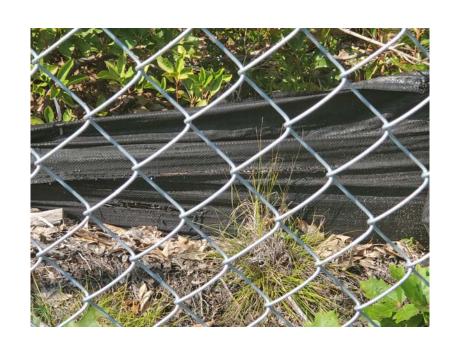
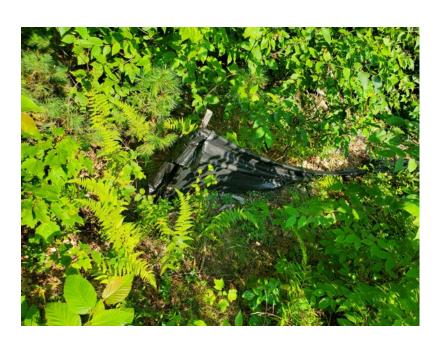
- Plastic silt fences create barriers to wildlife.
- Consider removing the plastic silt fences.
- If erosion controls are considered necessary, consider using biodegradable erosion socks with straw (not hay).

Construction phase silt fences still in place along eastern/northern project boundaries

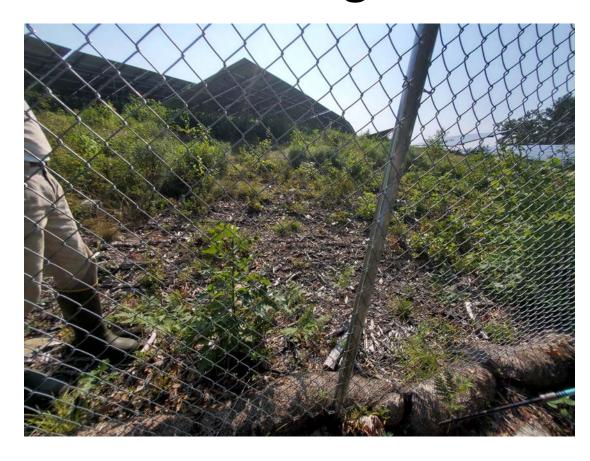
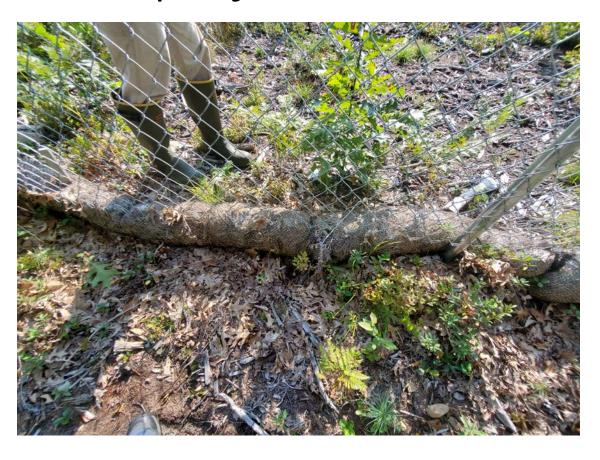
Incompletely vegetated slope and erosion sock along eastern side of project area

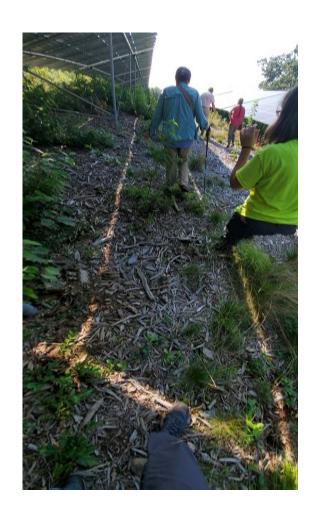
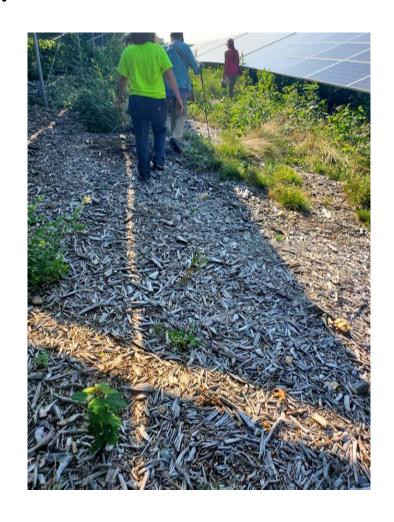
- Some scattered areas between arrays show thick layers of wood chips and insufficient vegetation.
- Conditions are reportedly much better than observed in 2020 site visit.
- Consider reseeding with soil amendment in select areas where natural vegetation unlikely to take hold due to lack of topsoil.

Areas with incomplete vegetation between arrays

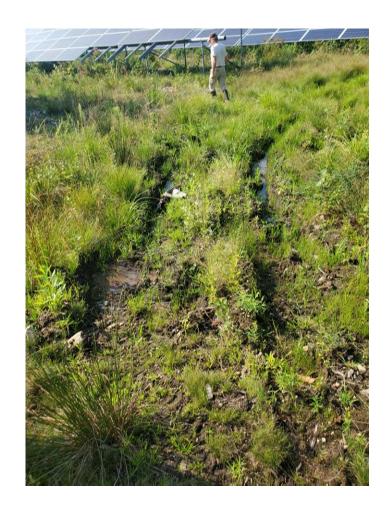
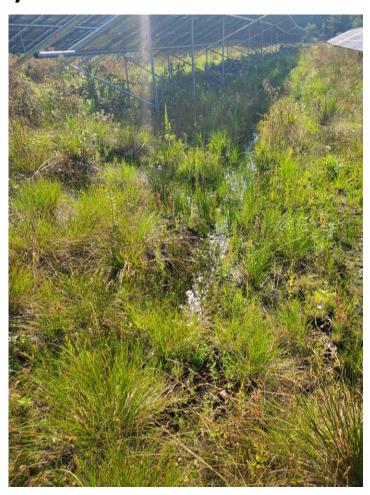
Equipment ruts with standing water around arrays

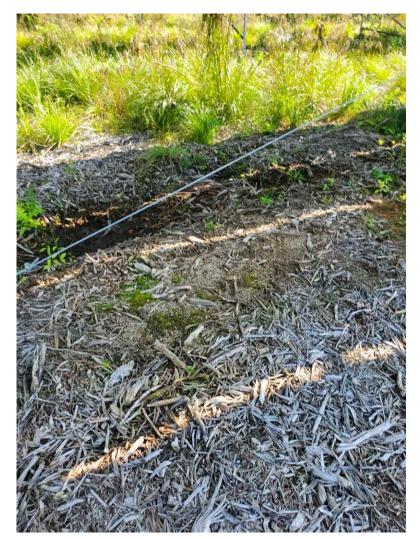
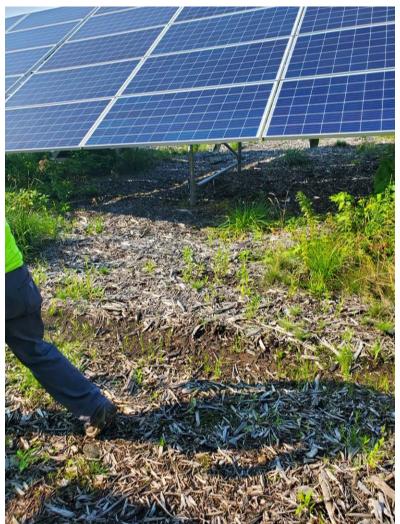
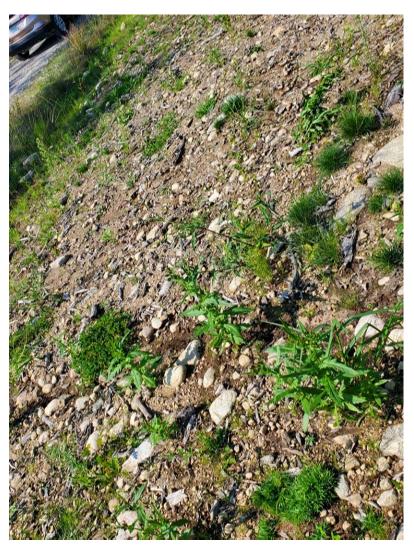
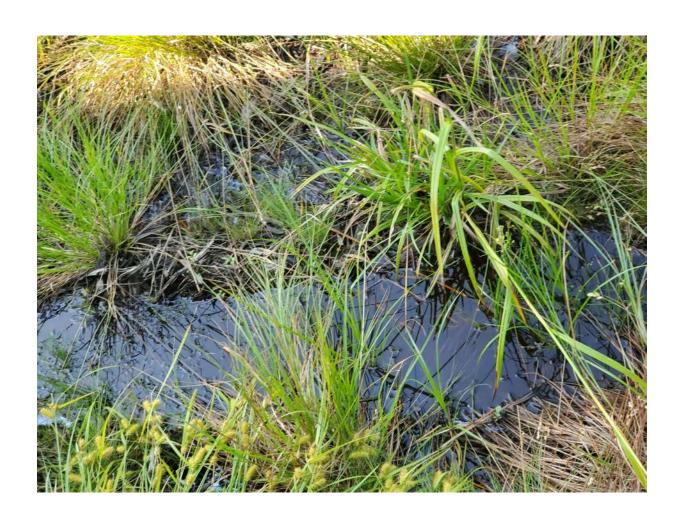
Scattered areas of incomplete vegetation between arrays

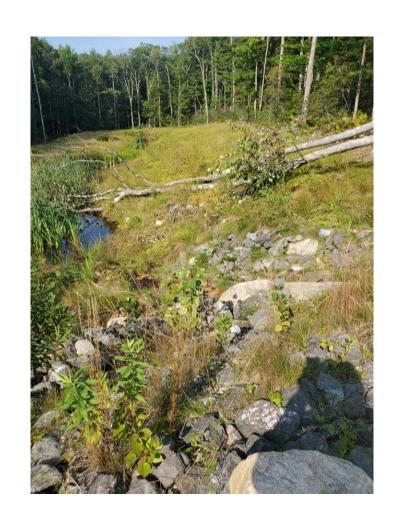
- Consider an additional stormwater features to divert and contain water coming down along the driveway. **ConCom RDA may be required if work near a wetland.**
- Dead tree in wetland is creating sieve conditions and should be removed.

Tree down in detention basin

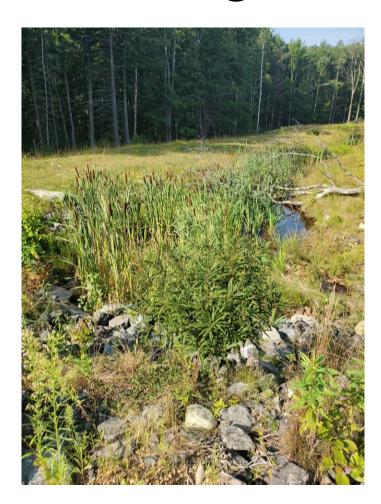
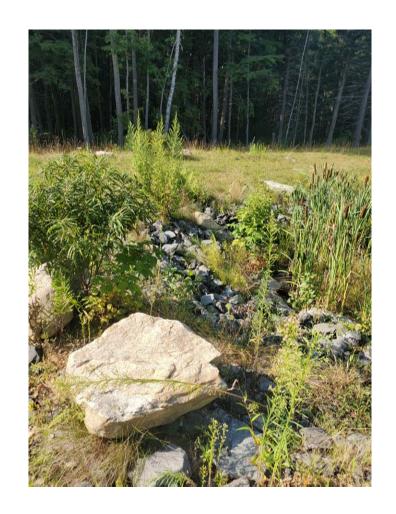
- Basin was designed as an infiltration basin, but it is now functioning as a wetland with persisting water, wetlands vegetation, and evidence of wetlands organisms.
- Excess water may be due to soil conditions, high groundwater levels and/or surface runoff conditions.
- Continuous water in the basin reduces the amount of designated basin storage during storms.
- Some evidence noted of past discharge through outlet, though no evidence of sediment discharge into downgradient wetlands.

Eastern view of detention basin showing cattails, evidence of long-term surface water

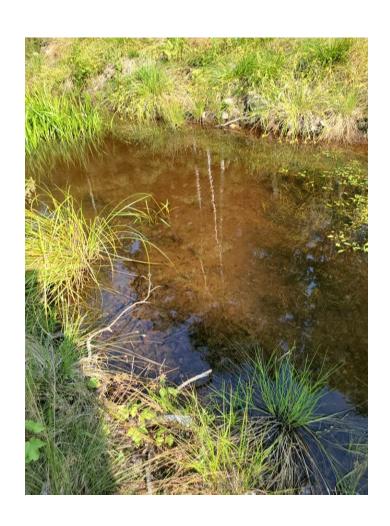
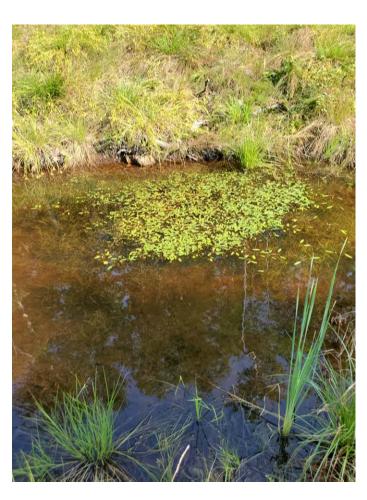
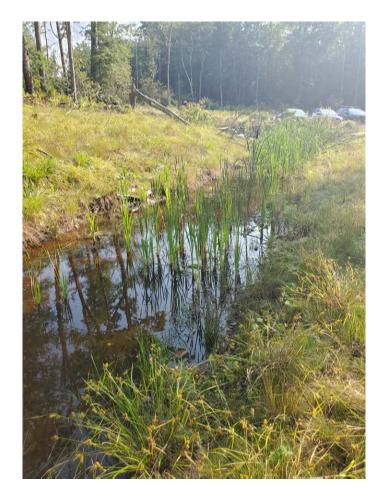
Detention basin showing wetlands vegetation. Large quantities of frogs observed in basin.

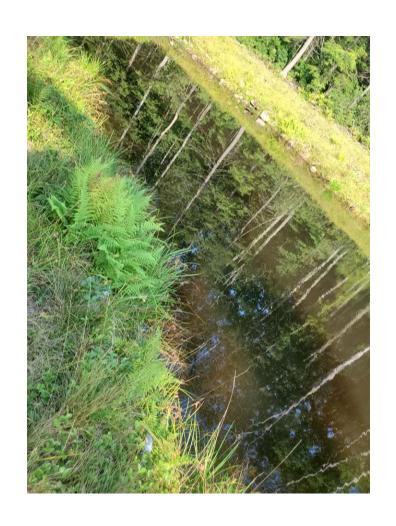
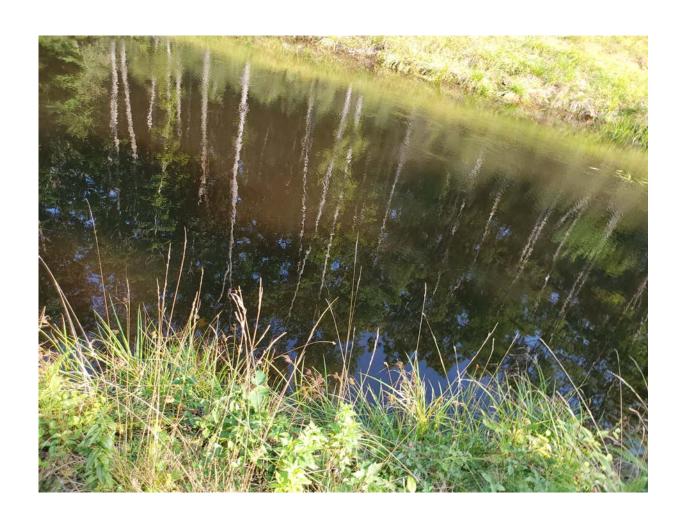
Eastern end of detention basin, showing deeper water. Bottom not visible.

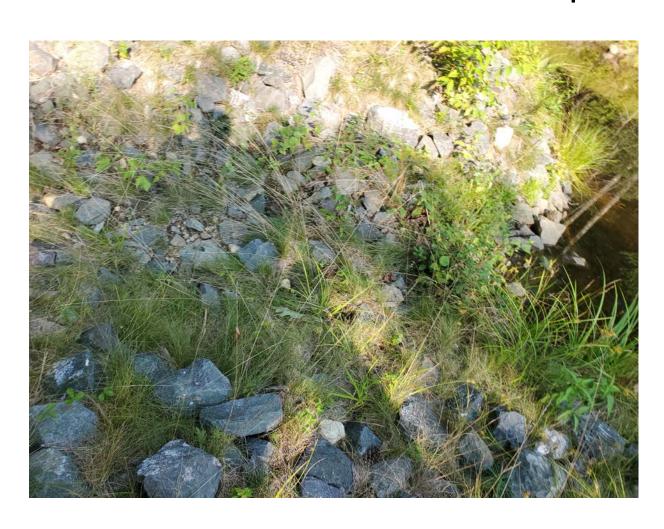
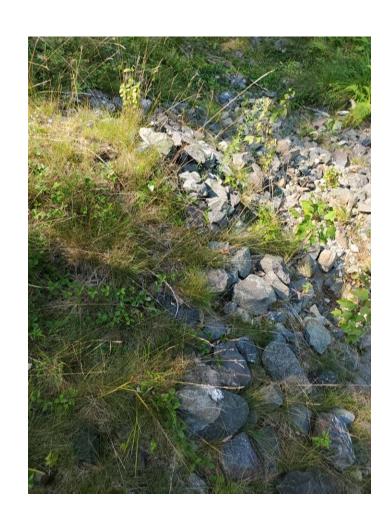
Detention basin outlet showing signs of erosion and past scour

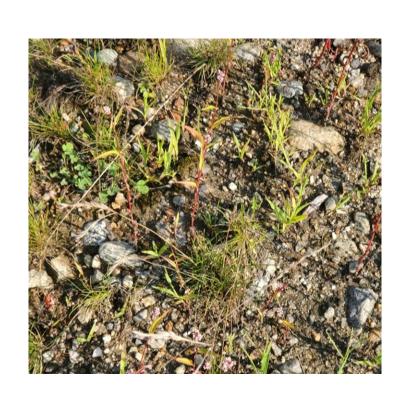
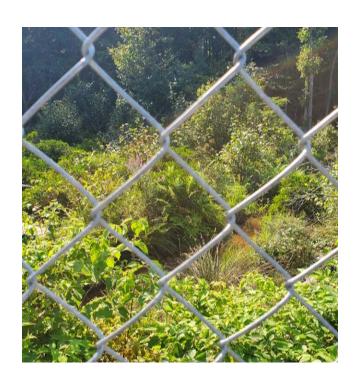
- No large areas of established invasive plant species were observed.
- Some areas showed beginning invasives presence (ex. Lysimachia/loosestrife).
- Recommend manual spot removal of invasive plants to prevent establishment.

Some invasive species observed: persicaria and lysimachia
