Re: Request for Chapter 21E Investigation

AD Makepeace Carverside Bogs, Plymouth Assessor's Map 126, Lots 7 and 11

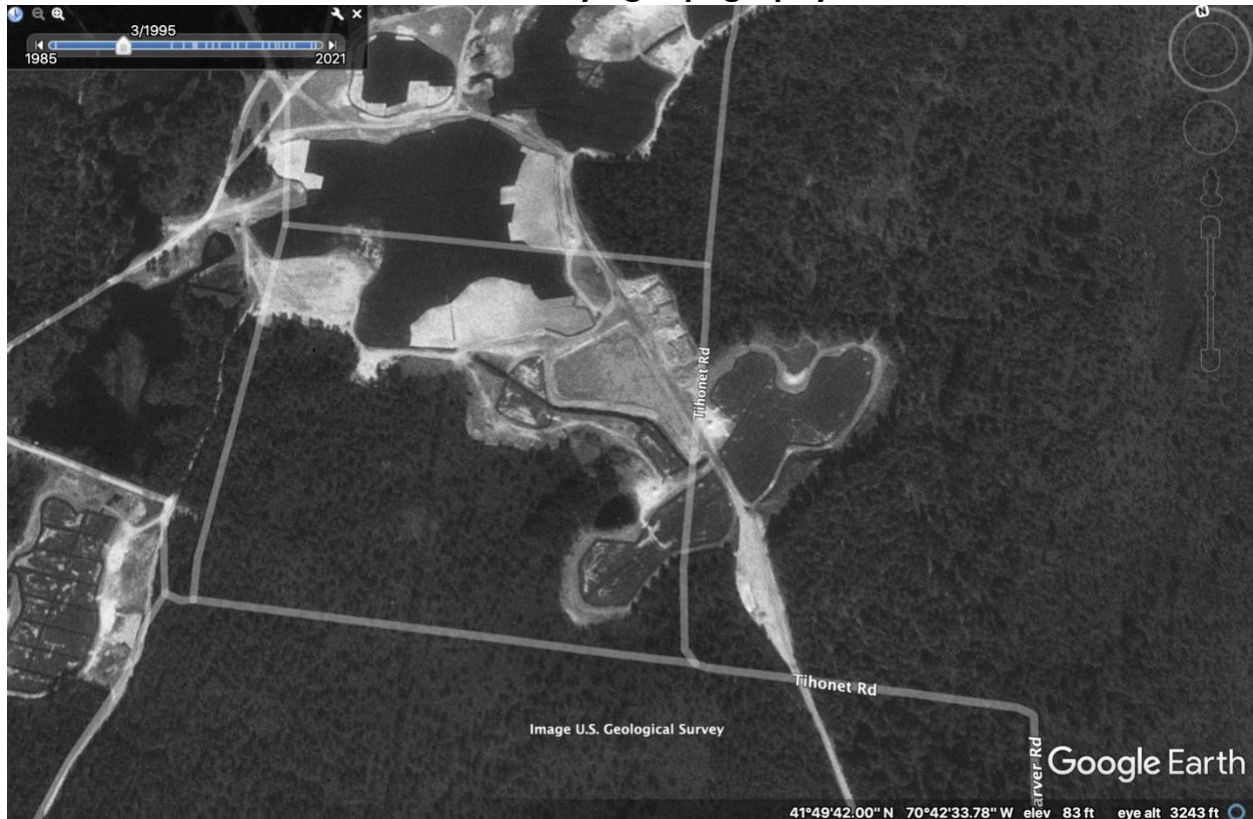
March 1995: site is wooded with varying topography.

This request is based on Google Earth photos with a timeline from March 1995. These show the area where the disposal occurred was wooded as of 1995. Mass Mapper shows varied topography with hills. As of December 2004, the area was cleared of trees, vegetation and stumps and mining was occurring.

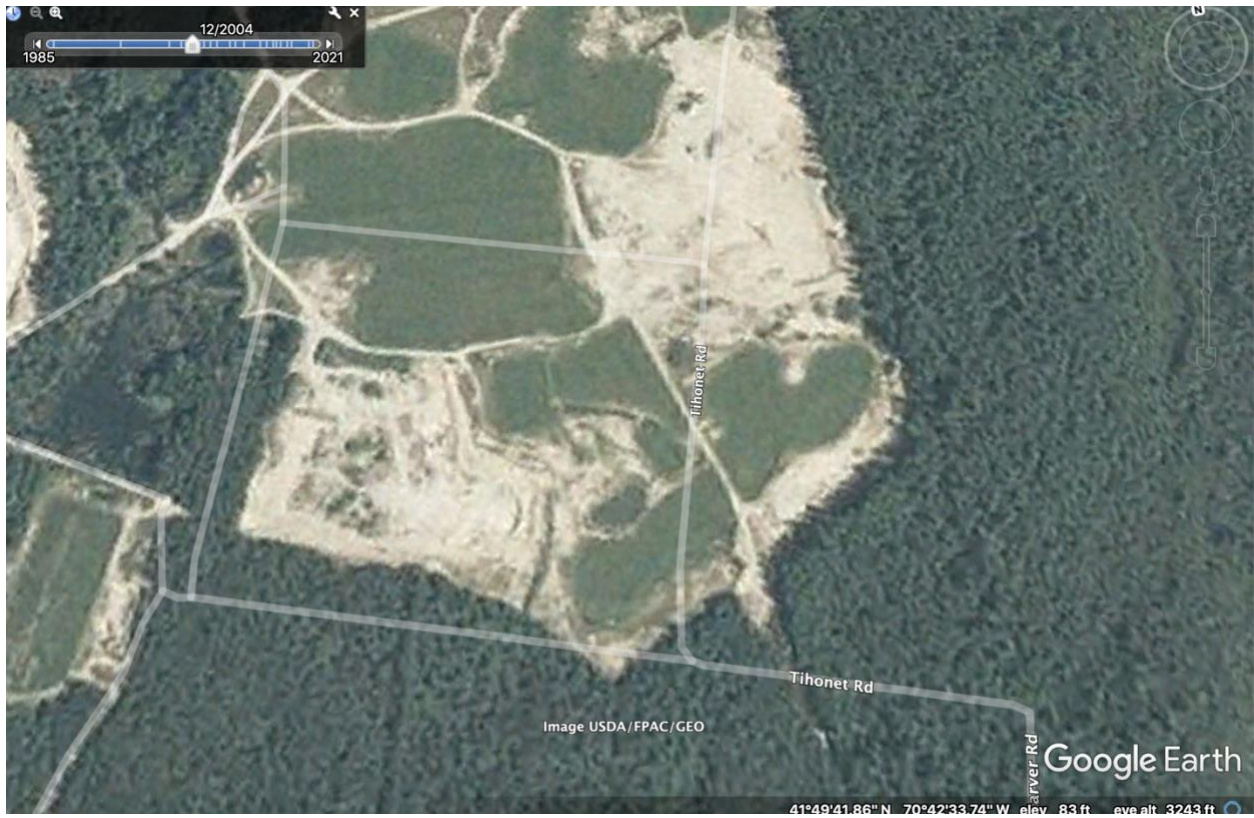
Below: December 2004: trees have been cleared, excavation is occurring.

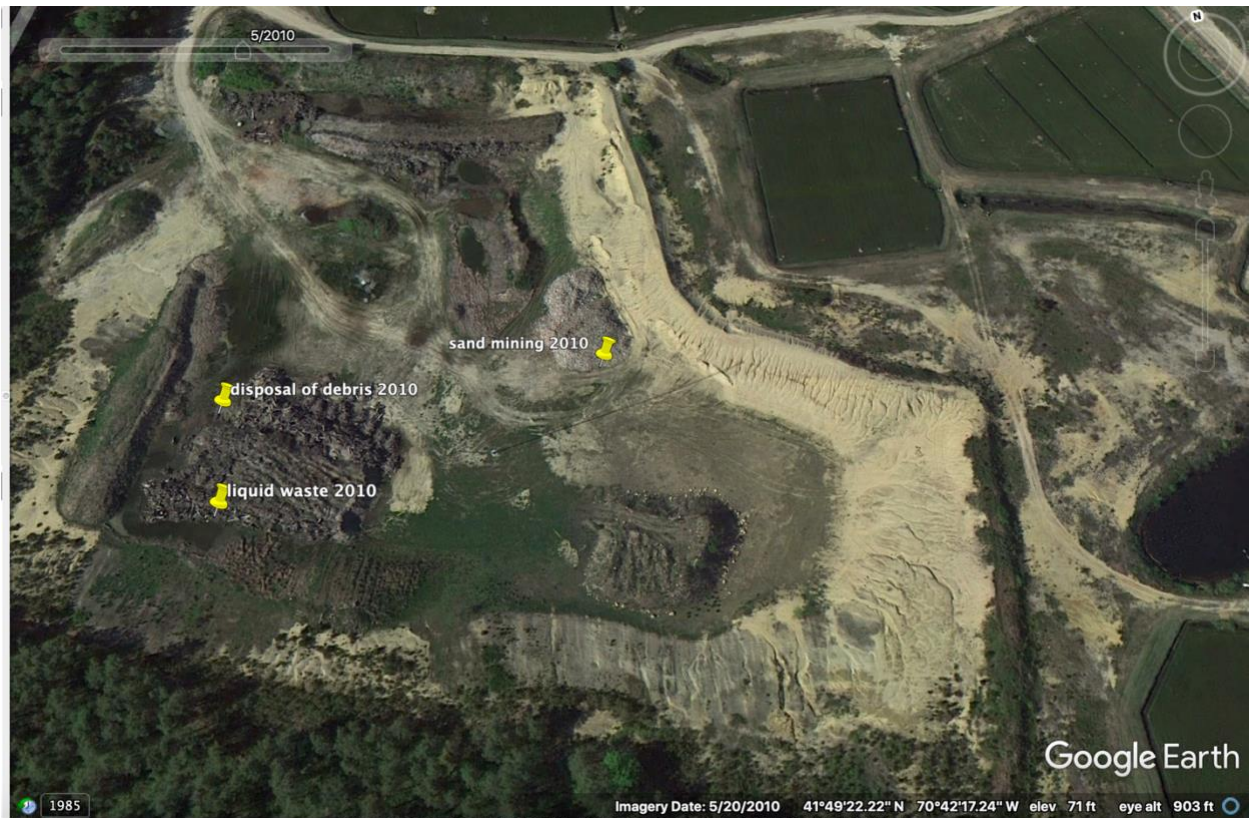
Below: May 2010: disposal of debris, what appears to be liquid waste. Sand mining occurring.

By 2010, there is disposal occurring on the site. Satellite images appear to show woody debris, logs, stumps and liquid waste.

The Google Earth images of the disposal of debris and liquid waste has been corroborated by eye witness testimony of person(s) who made personal observations of the site at the time the disposal occurred. It was reported that sewage waste was disposed of on the site, based on visual observations and odors.

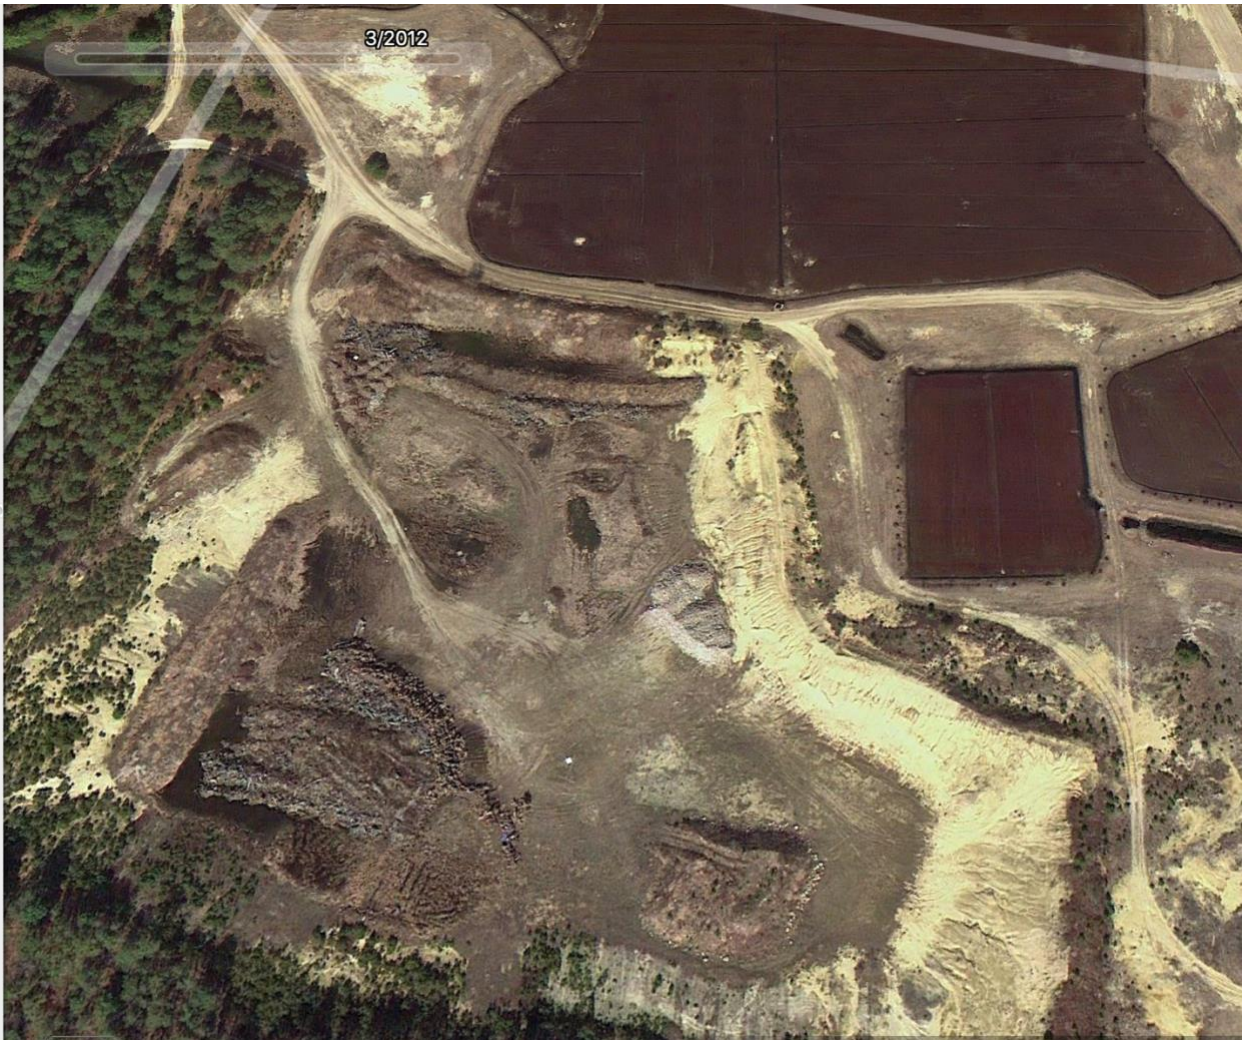
Below: 2012: Debris on the site.

In 2012 images, debris continues to be present, along with mining. By 2014, four years after the dumping appears to have started, the disposal area appears to be filling in.

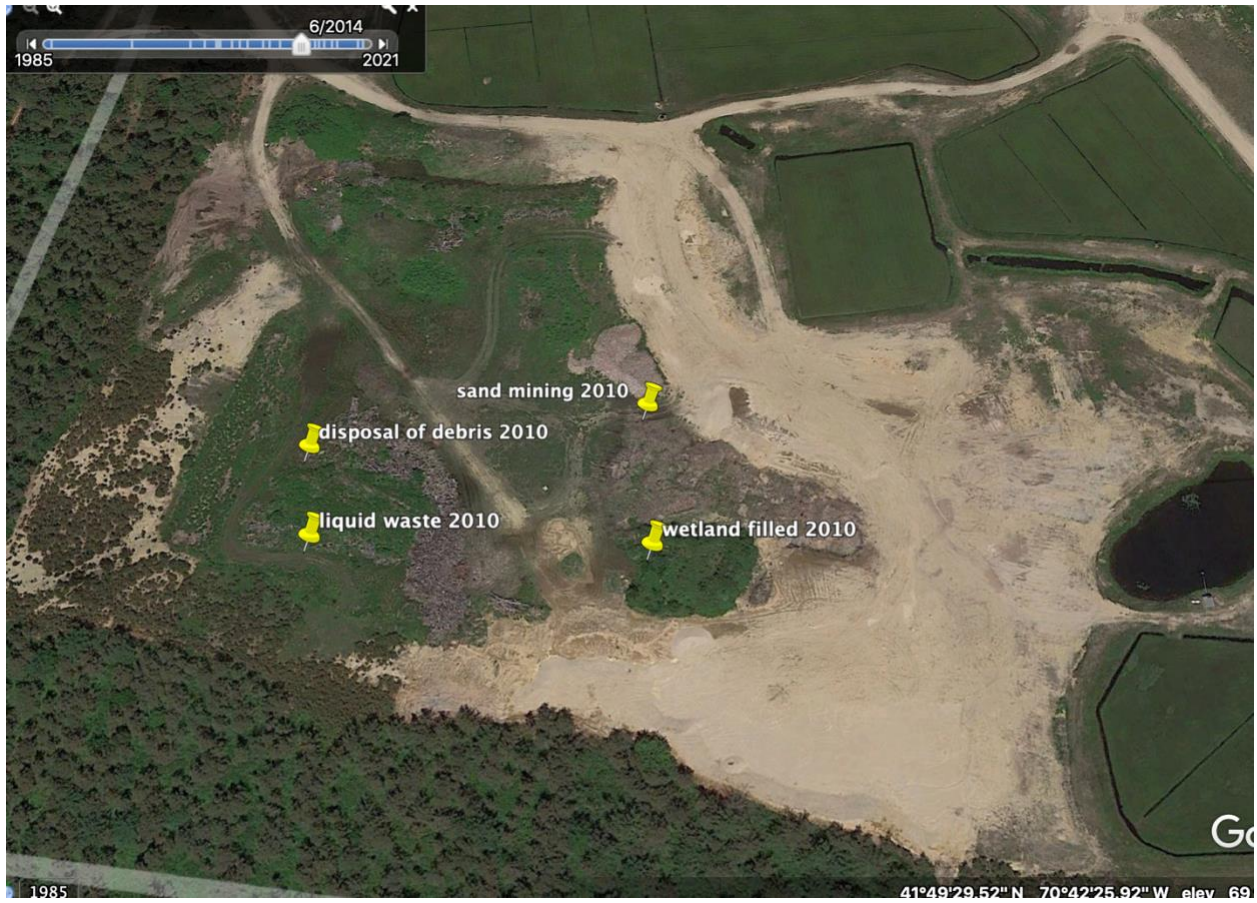
Below: 2014: mining, site filling in

In 2014, mining is continuing on the east side of the site, debris appears in the center and the west side appears to be filling in. In 2016 mining continues and a tractor trailer truck is visible on the site. The site is beginning to be covered over with sand. By 2021 the site was covered over with sand and earth materials and 93 acres of cranberry bog were built. It is reported that the bogs are not producing marketable cranberries as of 2021 for an unknown reason.

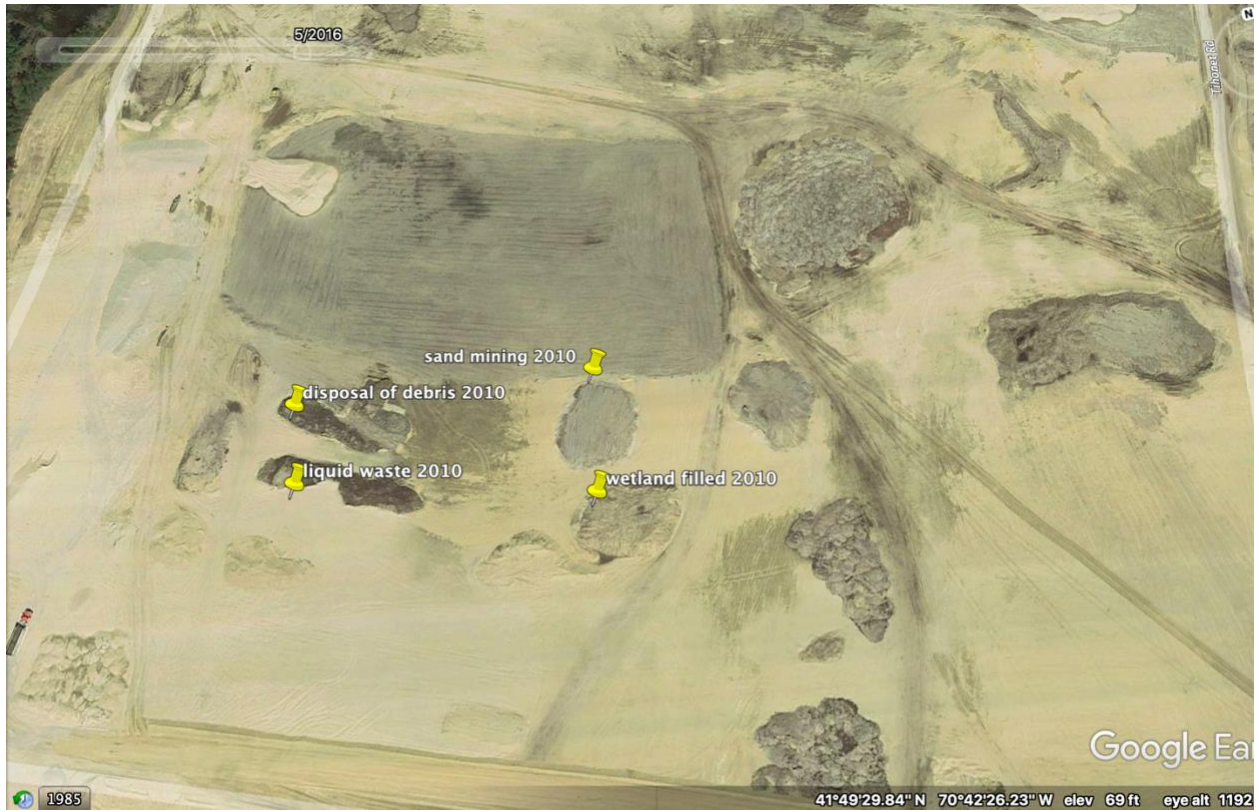
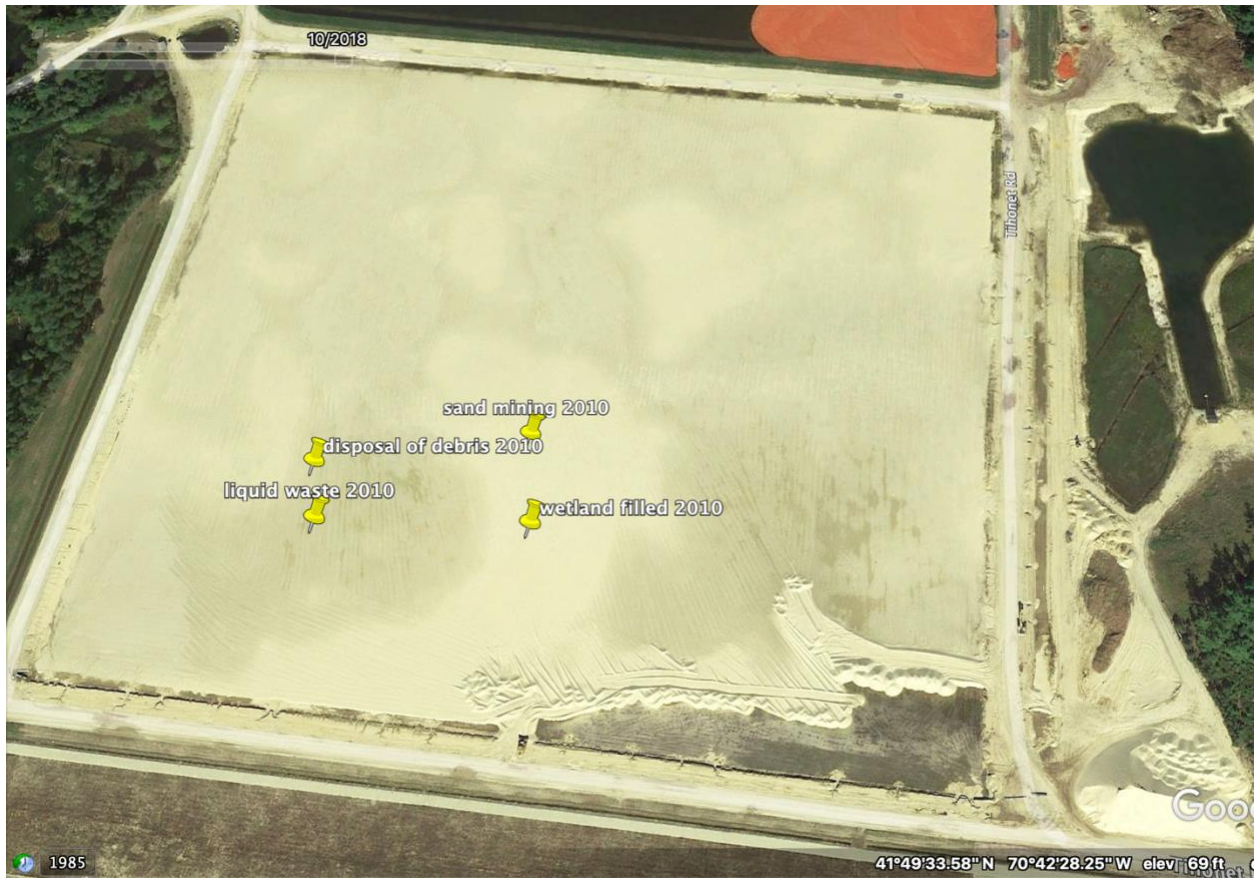
Below: 2016 sand being placed on the site
